Saline County SWCD
(618) 252-8621 ext. 3
Streambank Stabilization Restoration Project

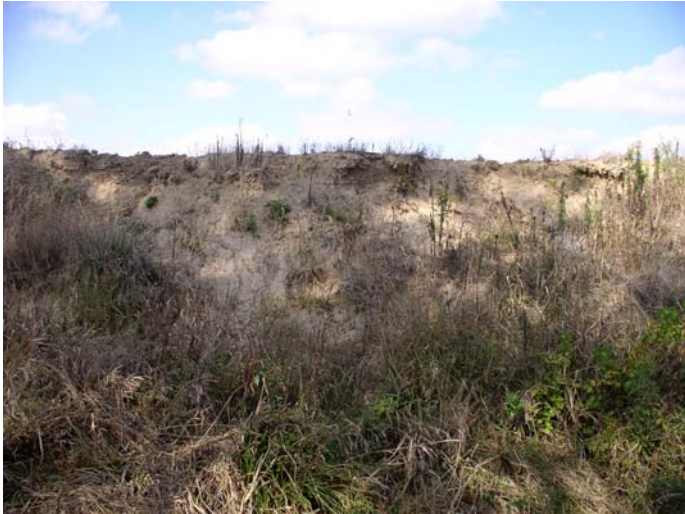
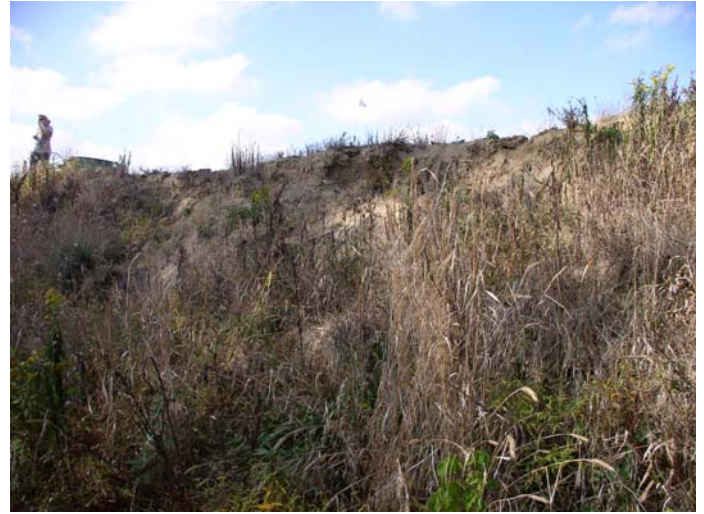
Above: Pictures of scouring on a streambank. This stream bank is on the edge of an 80 acre field with row crops being taken into the creek by erosion.

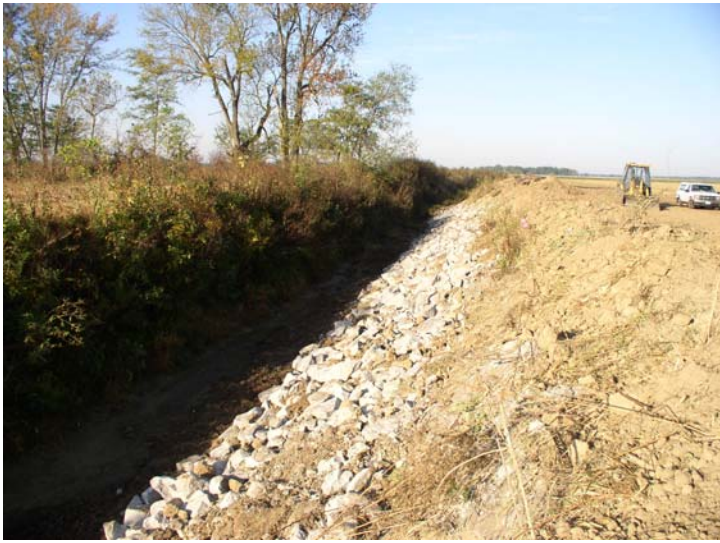
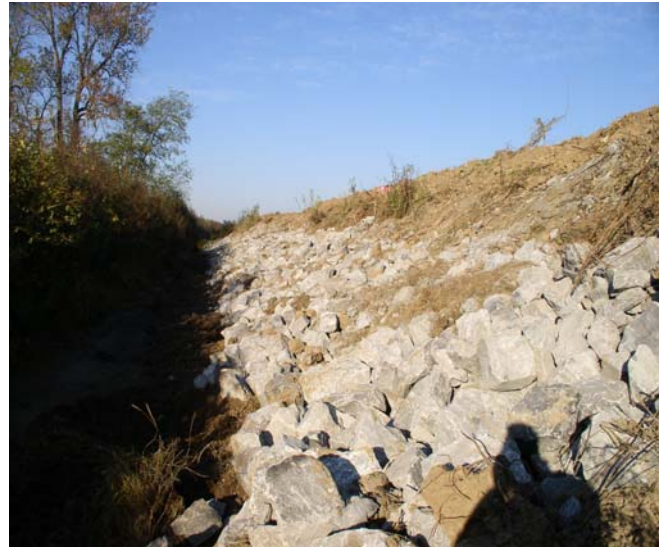
Below: You can see rock having been placed and the sides of the banks pulled back to discourage erosion. A field border strip could be an added benefit to discourage this from re-occurring.
